SERVICE ALERT

NO.: 0936 Revision B

SUBJECT: Navigation error condition concerning terminal procedures with Direct-to-Fix (DF) legs

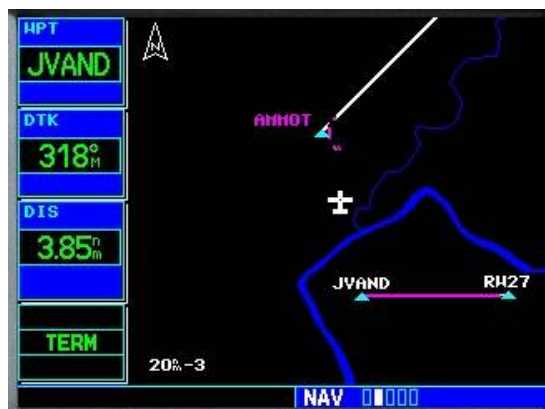
- a) Waypoint alerts are not provided at the waypoint prior to the automatic Direct-to-fix leg.
- b) The selected course, desired track, and CDI provide guidance to a non-published course. The non-published course may be depicted by Pathways (if equipped), but is NOT displayed on the navigation map.
- c) The previous leg of the flight plan remains shown as a magenta line on the navigation map, though it is no longer the active leg.
- d) On the GNS 400W/500W series, the previous waypoint of the flight plan is incorrectly displayed as the active waypoint.

Figures 1 and 2 show the magenta course line behind the aircraft position.

Figure 2. GNS 400W/500W Series Display While on Second DF Leg

Do not rely on automatic sequencing of Direct-to-fix waypoints. Do not delete an active Direct-to waypoint from the flight plan. If any of the above indications occur at any time, stay on the published course using back-up navigation techniques and manually activate a Direct-to leg using the Direct-to button (

400W/500W Series Main Software version 3.30 corrected this issue as described in Garmin Software Service Bulletin 0918 Revision A.
