SERVICE ALERT

NO.: 1202 Rev A

TO: Owners/Operators of Garmin GTN 650/750 Units
DATE: February 1, 2012
SUBJECT: GTN 650/750 Units and OBS Issue

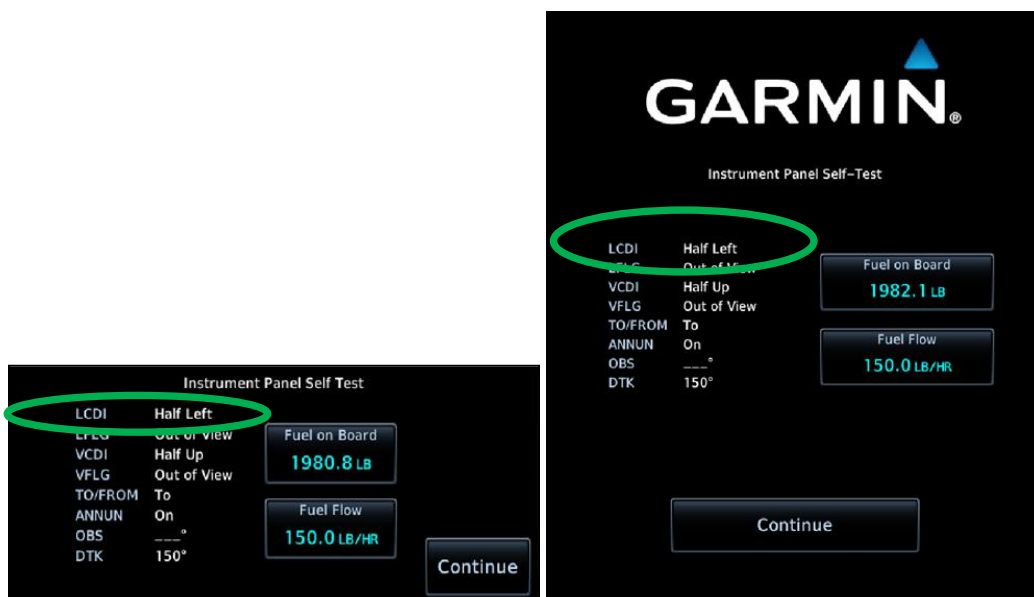
GTN 650 & 750 Instrument Panel Self-Test Page

1. Power up all avionics.
2. On the GTN unit, navigate to the **Instrument Panel Self-Test** Page. The lateral CDI (LCDI) output from the GTN is set to "Half Left" while on this page.

3. If the CDI indicated one-half full scale left deflection, the installation is not affected and this Service Alert does not apply.
4. If the CDI does NOT indicate one-half full scale deflection left (CDI needle remains parked) determine the Nav Board software version with the following steps:
 - a. Power up the GTN.
 - b. From the Home screen, touch the 'System' button.
 - c. From the System screen, touch the 'System Status' button.
 - d. For 650 Units only: Touch the 'Version Information' button.

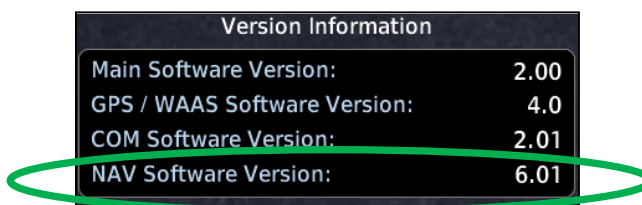
The NAV Software Version is displayed on the 'System – System Status' screen.

5. If Nav Board software version 6.01 is confirmed, do not use the CDI for VOR navigation. The CDI can continue to be used for Glideslope, ILS, Localizer, Localizer-Back Course, or GPS Navigation.
