SERVICE ALERT

NO.: 1504 Rev A

TO: Owners/Operators of G1000 Equipped Beechcraft 200 and B200 King Air Aircraft

SUBJECT: GRS 7800 AHRS

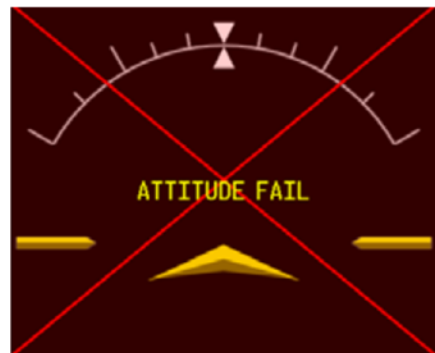
Heading and/or attitude information may become unavailable when the propeller RPM is set between 1920 and 1960 RPM. Either or both GRS 7800 AHRS may be affected. The attitude and bank shown on PFD1 and/or PFD2 may briefly show deviations. This condition is identified by a "ROLL" or "PITCH" flag and a "ROL MISCOMP" or "PIT MISCOMP" annunciation on both PFDs, followed by an Attitude Fail red X (see Figure 1).

Figure 1 – Attitude Fail

Do not dwell at 1920 to 1960 propeller RPM. If the conditions described above are observed, adjust propeller RPM below 1920 RPM or above 1960 RPM.

This issue will be resolved in a future GRS 7800 hardware change.
