## SERVICE ADVISORY

NO.: 1530 Rev A

**SUBJECT:** Potential Loss of FMS Navigation and Synthetic Vision (SVT)

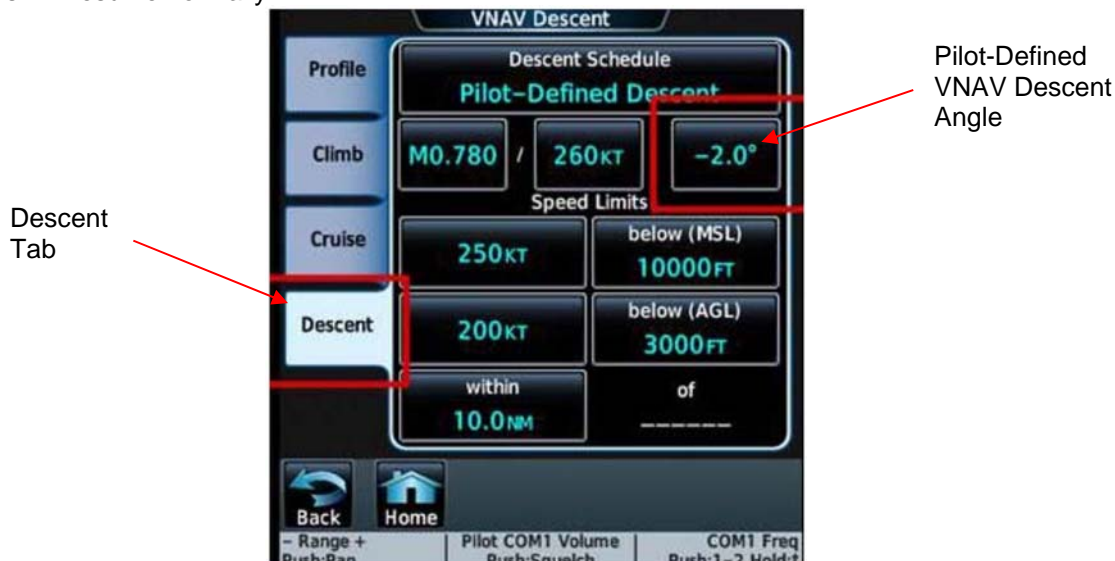
Figure 1 – Descent Tab of the VNAV Profile Page Showing the VNAV Descent Angle

If the pilot-defined VNAV descent angle (Descent tab of the VNAV Profile page, see Figure 1) is less than or equal to the minimum allowable (shallowest) setting, SVT, FMS, AFCS (if coupled), and navigation functions may be interrupted for up to ten seconds. The condition will clear after ten seconds and all functions will resume normally.

For the G3000 Cessna Citation CJ3+ and G3000 Cessna Citation M2 do not set the pilot-defined VNAV descent angle at or below the minimum allowable (shallowest) setting (-2.0°).

For the G5000 Cessna Citation Sovereign and the G5000 Cessna Citation X+ do not set the pilot-defined VNAV descent angle below the minimum allowable (shallowest) setting (-0.5°).
