SERVICE ADVISORY

NO.: 20109 Rev B

TO: Owners and Operators
DATE: November 5, 2020
SUBJECT: Erroneous GPS position and momentary false TAWS alerts
REVISION B: Added the G1000(H) NXi

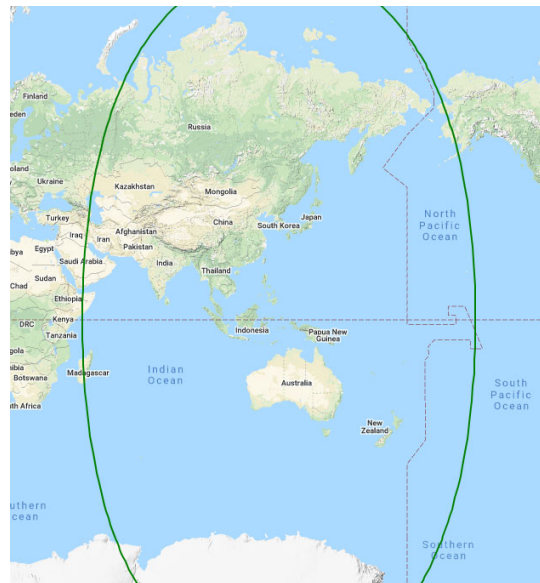
All SBAS-enabled Garmin Integrated Flight Decks (G900X, G950, G1000(H) G1000(H) NXi, Cirrus Perspective™, Embraer Prodigy™, G2000, G3000, G5000, and Embraer Prodigy® Touch systems), GTN Xi Series, GPS 175, GNX 375, GNC 355, GNS 400W/500W Series, GNS 480, GTN 6XX/7XX Series products operating within the area depicted below are affected.

Affected Garmin equipment may periodically experience GPS position errors for approximately six seconds, and momentary TAWS false alerts when utilizing corrections from the Japanese MSAS (MTSAT Satellite Augmentation System) space-based augmentation system.

Disable MSAS.

MSAS will be disabled automatically in the November 2020 aviation database cycle. A future software and database update will address the issue and re-enable the use of MSAS in the affected products.
